**Flood Control Project Maintenance
Levee Inspections**
LMA District Cover Sheet
Spring 2017 Levee Inspection Results

Sutter Maintenance Yard Maintenance Area 0001

Spring 2017 Levee Inspection Results

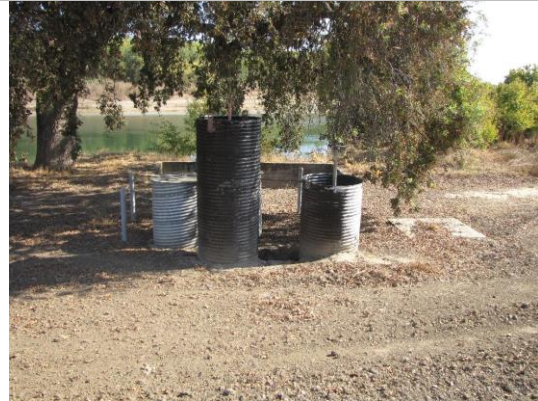
Photo 3 of 3 : UCIP_SP_2017_51893_70330.jpg

Comment Code					
Inspector Comment					
FS_ID:51893 DS_ID:17691 EP_NO: 17471 Repair Type: Urgent Crossing Status: Found UCIP Comments: 5/3/2017 Sink hole still present between the WS risers. It does not appears to be getting worse. Pumps were running during site visit but the sink hole was dry this time. (DWR Sutter Yard-AFreitag)10/24/2016 Sinkhole still present.(DWR Sutter Yard-AFreitag)4/25/2016 Sink hole between the standpipes seems to be getting worse. Measurements of the hole are 3' wide x 3' long x 3' deep. The pipe was flowing water and there was water present in the bottom of the sink hole. (DWR Sutter Yard - afreitag)4/21/2015 Sink hole still present between risers. (DWR Sutter Yard - afreitag)6/23/2014 Standing water was present in the bottom of the sinkhole. (DWR Sutter Yard - afreitag)12/17/2013 Same as last inspection. (DWR Sutter Yard - afreitag)7/18/2013 Same as last inspection. (DWR Sutter Yard - afreitag)10/30/2012 Erosion between risers with slide gates located on waterward side; This crossing was listed in the USACE Periodic Inspections as ID# USACE_CESPK_MA1C_2010_p_0398 for possible sinkhole between access gate structures. (DWR UCIP - omagana) FIELD_STRUCT_DESC: 1 of 2: 24-inch high-density polyethylene (HDPE) irrigation pipe to be connected to the existing corrugated metal pipe (CMP) riser within the waterside (WS) and parallel to the right (west) bank levee of the Sacramento River. (Permit 17471, 2002 - Maxwell Irrigation District). FS Date: 5/23/2017 10:52:09 AM

CMP risers located on WS berm. 18-inch pipe corresponds to downstream riser with slide gate. 24-inch pipe corresponds to upstream riser with slide gate.

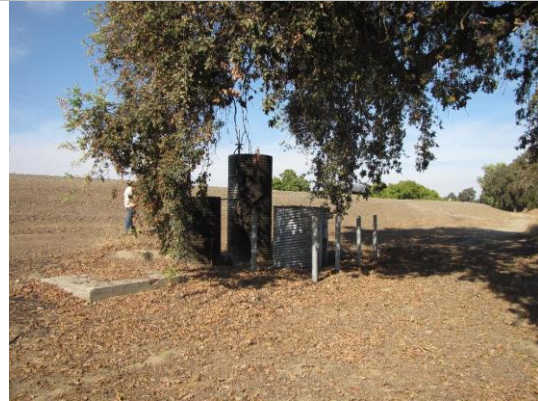
Photo 3 of 3 : UCIP_SP_2017_51894_70323.jpg

Comment Code					
Inspector Comment					
FS_ID:51894 DS_ID:17624 EP_NO: 17471 Repair Type: Urgent Crossing Status: Found UCIP Comments: 5/3/2017 Sink hole still present between the WS risers. It does not appears to be getting worse. Pumps were running during site visit but the sink hole was dry this time. (DWR Sutter Yard-AFreitag)10/24/2016 Sinkhole still present.(DWR Sutter Yard-AFreitag)4/25/2016 Sink hole between risers was getting worse (3' wide x 3' long x 3' deep). New smaller sink hole is appearing on the upstream side of this stand pipe (4.5" wide x 20" deep). (DWR Sutter Yard - afreitag)4/21/2015 Sink hole still present between risers. (DWR Sutter Yard - afreitag)6/23/2014 Standing water was present in the bottom of the sinkhole. (DWR Sutter Yard - afreitag)12/17/2013 Same as last inspection. (DWR Sutter Yard - afreitag)7/18/2013 Same as last inspection. (DWR Sutter Yard - afreitag)10/30/2012 Erosion between risers with slide gates located on waterward side; This crossing was listed in the USACE Periodic Inspections as ID# USACE_CESPK_MA1C_2010_p_0398 for possible sinkhole between access gate structures. (DWR UCIP - omagana) FIELD_STRUCT_DESC: 2 of 2: 18-inch high-density polyethylene (HDPE) irrigation pipe connected to the existing corrugated metal pipe (CMP) riser within the waterside (WS) and parallel to the right (west) bank levee of the Sacramento River. Pipe depth through the levee unknown. Pump station is located approximately 450 feet upstream of crossing. (Permit 17471, 2002 - Maxwell Irrigation District) FS Date: 5/23/2017 10:55:17 AM

View of CMP risers located on WS berm.

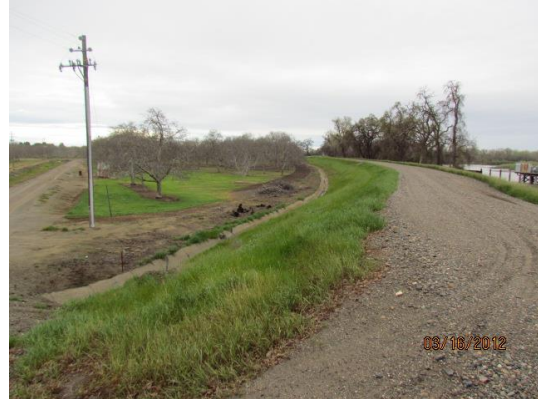
Photo 1 of 1 : SP_2017_MA0001_297_27_20170315_00014.jpg

LM Start	11.21	Rating **	M	Issue No.	27
LM End	11.46	Issue Type +	En	Location *	LS
Category	Earthen Levee			GPS Latitude/Longitude	
				Start	End
Item	Encroachments			39.343542 °	39.347185 °
				-122.032107 °	-122.031525 °
DWR ID	DWR_MA0001_01_s_2012_27				
Comment Code					
DT : Ditch					
Inspector Comment

View of the ag. ditch along the landside toe.

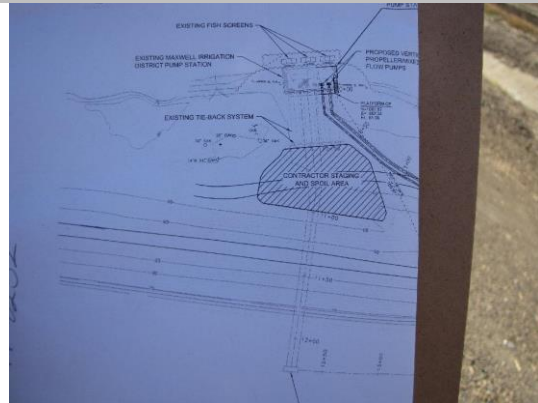
Photo 1 of 3 : UCIP_SP_2017_51900_70342.jpg

Comment Code					
Inspector Comment					
FS_ID:51900 DS_ID:20584 EP_NO: N/A Repair Type: Non-Urgent Crossing Status: Found UCIP Comments: 5/3/2017 Crossing appears to be in good condition. (DWR Sutter Yard- AFreitag)10/24/2016 appears to be in good condition.(DWR Sutter Yard- AFreitag)4/25/2016 Crossing appears to be in good condition.4/21/2015 Same as last inspection.6/23/2014 Same as last inspection.12/17/2013 Same as last inspection.7/22/2013 Same as last inspection.10/30/2012 Need to determine encroachment permit for this crossing. FIELD_STRUCT_DESC: [Maxwell Irrigation District] 3 of 3: 24-inch steel irrigation pipe through the levee at an unknown depth below the crown. Crossing is tied to existing Maxwell Irrigation District Pump Station located on the waterside (WS). Siphon breaker inside corrugated metal pipe (CMP) riser located on the landside (LS) shoulder. No permit has been identified since crossing was field discovered in 2012. FS Date: 5/23/2017 11:47:50 AM

Drawing of existing Maxwell Irrigation District Conveyance Pipeline
(DWG available through Permit No. 17471 for work located at LM 11.51).

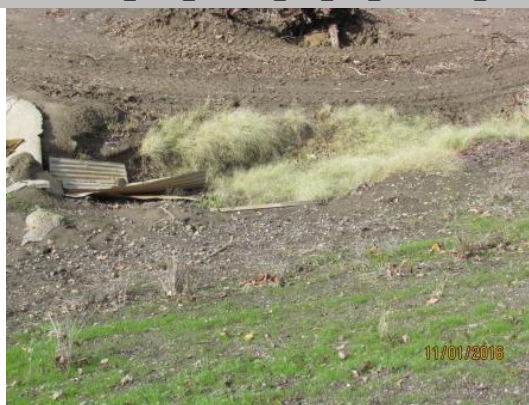
Photo 1 of 1 : SP_2017_MA0001_297_121_20170315_00050.jpg

View of the low spot along the levee toe created by adjacent ditch overflow.

LM Start	11.46	Rating **	M	Issue No.	121
LM End	11.46	Issue Type +	Ma	Location *	LS
Category	Earthen Levee			GPS Latitude/Longitude	
				Start	End
Item	Slope Stability			39.347168 °	39.347168 °
				-122.031533 °	-122.031533 °
DWR ID	DWR_MA0001_01_f_2016_121				
Comment Code					
S1 : Repair slope instability.					
Inspector Comment					
Backfill and compact.

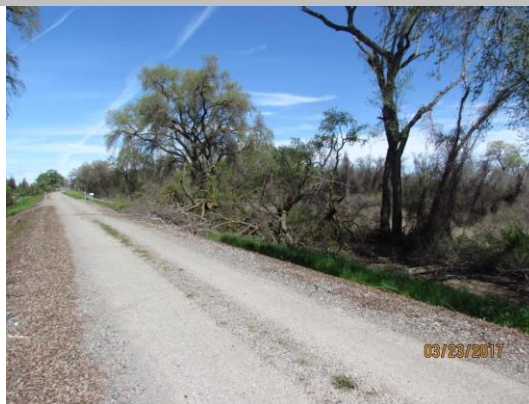
Photo 1 of 1 : SP_2017_MA0001_297_149_20170330_00185.jpg

View of the trees on the waterside slope and toe.

LM Start	11.52	Rating **	M	Issue No.	149
LM End	11.52	Issue Type +	En	Location *	WS
Category	Earthen Levee			GPS Latitude/Longitude	
				Start	End
Item	Encroachments			39.348040 °	39.348040 °
				-122.031295 °	-122.031295 °
DWR ID	DWR_MA0001_01_s_2017_149				
Comment Code					
TR : Tree or limb					
Inspector Comment					
Remove the trees from the waterside slope and toe.

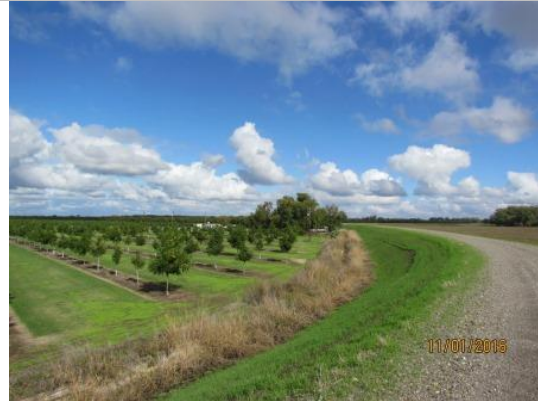
Photo 1 of 1 : SP_2017_MA0001_297_122_20170315_00051.jpg

View of the Johnson grass along the levee toe and concrete lined ditch.

LM Start	12.24	Rating **	M	Issue No.	122
LM End	12.36	Issue Type +	Ma	Location *	LS
Category	Earthen Levee			GPS Latitude/Longitude	
				Start	End
Item	Vegetation			39.357322 °	39.358283 °
				-122.026590 °	-122.024717 °
DWR ID	DWR_MA0001_01_f_2016_122				
Comment Code					
V1 : Control annual grass and weeds on the levee slopes and easements.					
Inspector Comment

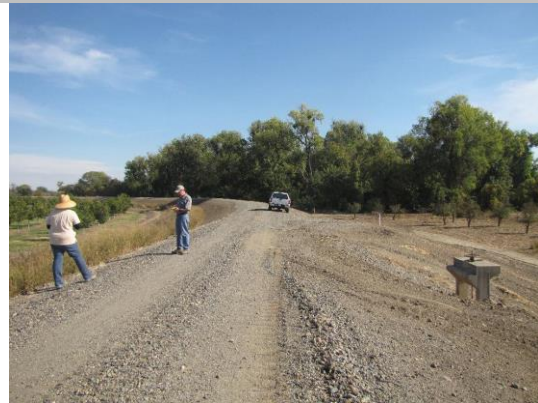
Photo 1 of 3 : UCIP_SP_2017_51903_70352.jpg

Comment Code					
Inspector Comment					
FS_ID:51903 DS_ID:16445 EP_NO: 9462 Repair Type: Non-Urgent Crossing Status: Found UCIP Comments: 5/3/2017 Appears abandoned- needs to be done properly.(DWR Sutter Yard- AFreitag)10/24/2016 Appears abandoned. LS concrete canal is filled by pipe DSID 16444.4/25/2016 Appears to be an abandoned crossing. WS slide gate still buried and inoperable.4/21/2015 Same as last inspection. 6/23/2014 Same as last inspection.12/17/2013 Same as last inspection.7/22/2013 Same as last inspection.10/30/2012 Slide gate unoperable-blocked by sediment. LS-flap gate missing. 5-inch pipe goes through 24-inch crossing--unable to determine is authorized. This crossing was listed in the USACE Periodic Inspections as ID# USACE_CESPK_MA1C_2010_p_0435 for smaller pipe running inside existing crossing. FIELD_STRUCT_DESC: *ABANDONED* 24-inch corrugated metal drainage pipe through the levee, approximately 10 feet below the crown. Slide gate on both waterside (WS) and landside (LS). Gate missing on the LS. (Automatic Board Order (ABO) issued as Permit No. 9462-1974, Thousand Acre Ranch) [Additional Reference(s): DWR Levee Log, 1992]. FS Date: 5/23/2017 11:50:30 AM

Overview of levee crown looking downstream at crossing.

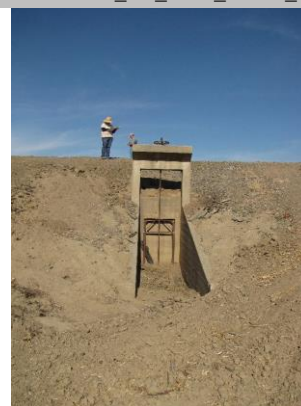
Photo 2 of 3 : UCIP_SP_2017_51903_70351.jpg

Item	DWR UCIP Field Study			39.359843 °	39.359843 °	
				-122.019529 °	-122.019529 °	
DWR ID						
Comment Code						
Inspector Comment						
FS_ID:51903 DS_ID:16445 EP_NO: 9462 Repair Type: Non-Urgent Crossing Status: Found UCIP Comments: 5/3/2017 Appears abandoned- needs to be done properly.(DWR Sutter Yard- A Freitag)10/24/2016 Appears abandoned. LS concrete canal is filled by pipe DSID 16444.4/25/2016 Appears to be an abandoned crossing. WS slide gate still buried and inoperable.4/21/2015 Same as last inspection. 6/23/2014 Same as last inspection.12/17/2013 Same as last inspection.7/22/2013 Same as last inspection.10/30/2012 Slide gate unoperable-blocked by sediment. LS-flap gate missing. 5-inch pipe goes through 24-inch crossing--unable to determine is authorized. This crossing was listed in the USACE Periodic Inspections as ID# USACE_CESPK_MA1C_2010_p_0435 for smaller pipe running inside existing crossing. FIELD_STRUCT_DESC: *ABANDONED* 24-inch corrugated metal drainage pipe through the levee, approximately 10 feet below the crown. Slide gate on both waterside (WS) and landside (LS). Gate missing on the LS. (Automatic Board Order (ABO) issued as Permit No. 9462-1974, Thousand Acre Ranch) [Additional Reference(s): DWR Levee Log, 1992]. FS Date: 5/23/2017 11:50:30 AM

WS concrete structure with slide gate. Gate is blocked by sediment.

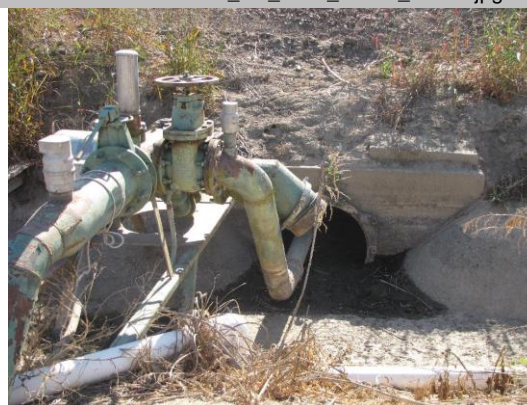
Photo 3 of 3 : UCIP_SP_2017_51903_70350.jpg

6-inch irrigation pipe through crossing at LS. Flap gate missing.

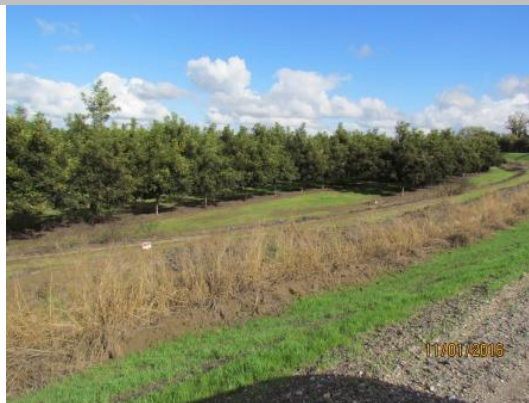
Photo 1 of 1 : SP_2017_MA0001_297_123_20170315_00052.jpg

View of the Johnson grass along the levee toe.

LM Start	12.69	Rating **	M	Issue No.	123
LM End	12.79	Issue Type +	Ma	Location *	LS
Category	Earthen Levee			GPS Latitude/Longitude	
				Start	End
Item	Vegetation			39.359810 °	39.359748 °
				-122.019402 °	-122.017600 °
DWR ID	DWR_MA0001_01_f_2016_123				
Comment Code					
V1 : Control annual grass and weeds on the levee slopes and easements.					
Inspector Comment

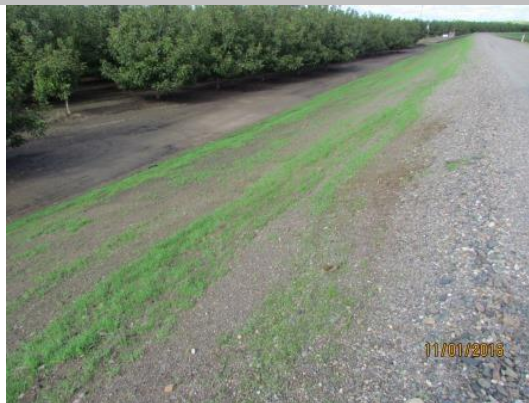
Photo 1 of 1 : SP_2017_MA0001_297_124_20170315_00053.jpg

View of the slope instability caused by vehicles along the landside slope.

LM Start	13.33	Rating **	M	Issue No.	124
LM End	13.33	Issue Type +	Ma	Location *	LS
Category	Earthen Levee			GPS Latitude/Longitude	
				Start	End
Item	Slope Stability			39.365748 °	39.365748 °
				-122.015633 °	-122.015633 °
DWR ID	DWR_MA0001_01_s_2017_124				
Comment Code					
S3 : Repair the levee slope damaged by vehicle traffic and prevent access where possible.					
Inspector Comment

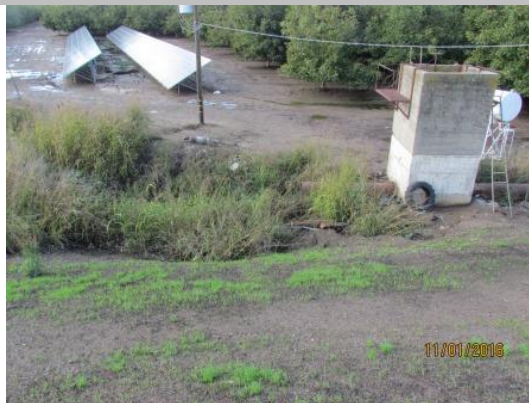
Photo 1 of 1 : SP_2017_MA0001_297_125_20170315_00054.jpg

View of the landside toe erosion caused by ag pipe.

LM Start	13.46	Rating **	M	Issue No.	125
LM End	13.46	Issue Type +	Ma	Location *	LS
Category	Earthen Levee			GPS Latitude/Longitude	
				Start	End
Item	Erosion / Bank Caving			39.367600 °	39.367600 °
				-122.015248 °	-122.015248 °
DWR ID	DWR_MA0001_01_f_2016_125				
Comment Code					
E1 : Note and monitor erosion site.					
Inspector Comment

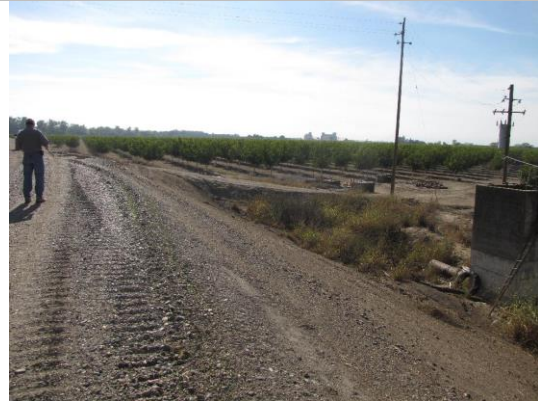
Photo 1 of 3 : UCIP_SP_2017_51908_70377.jpg

FS_ID:51908
DS_ID:16443
EP_NO: 9461
Repair Type: Urgent
Crossing Status: Found
UCIP Comments: 5/3/2017 Water was leaking from the LS distribution box during the Jan/Feb 2017 high water event. If this crossing is abandoned then it needs to be so properly. (DWR Sutter Yard- A Freitag) 11/01/2016 Erosion/cavity collapse visible on LS toe. Slide gate inside concrete riser located on the WS is in the open position. Need to contact owner to confirm status of crossing and to determine cause of erosion on LS (pipe or concrete box might be leaking). (O. Magana - DWR UCIP) 10/24/2016 Appears abandoned. (DWR Sutter Yard- A Freitag) 4/25/2016 Slide gate in WS box visually appears to be closed as its stem is all the way down. Still cannot look into box to confirm 100% though. (A. Freitag - DWR Sutter Yard) 4/21/2015 Same as last inspection. (A. Freitag - DWR Sutter Yard) 6/23/2014 Same as last inspection. (A. Freitag - DWR Sutter Yard) 12/17/2013 Same as last inspection. (A. Freitag - DWR Sutter Yard) 7/22/2013 Same as last inspection. (A. Freitag - DWR Sutter Yard) 10/30/2012 Unable to close positive closure device due to missing ladder-sluce gate inaccessible. Need to determine the condition of the gate. This crossing was listed in the USACE Periodic Inspections as ID# USACE_CESPK_MA1C_2010_p_0453 for an inaccessible gate box with its ladder broken on the waterward side. (O. Magana - DWR UCIP) FIELD_STRUCT_DESC: 36-inch corrugated metal irrigation pipe through the levee, 21.5 feet below the crown. Slide gate in concrete box on the waterside (WS) end. Pump on the bank. Tall concrete box located on the landside (LS). (Automatic Board Order (ABO) issued as Permit No. 9461, 1974 - Annie D. Propfe) [Additional Reference(s): DWR Levee Log, 1992. USACE Sacramento O&M Manual 137, August 1955, (Station 710+82)].

View of LS looking downstream at crossing.

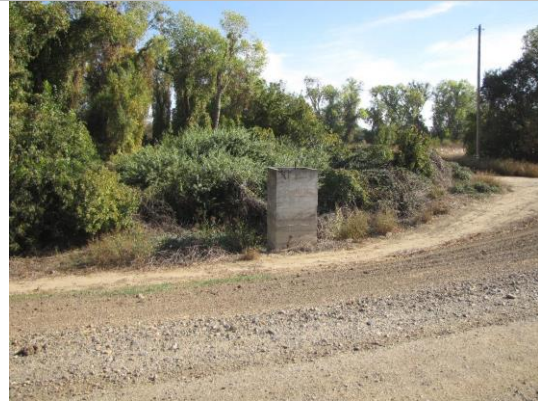
Photo 2 of 3 : UCIP_SP_2017_51908_70376.jpg

FS_ID:51908
DS_ID:16443
EP_NO: 9461
Repair Type: Urgent
Crossing Status: Found
UCIP Comments: 5/3/2017 Water was leaking from the LS distribution box during the Jan/Feb 2017 high water event. If this crossing is abandoned then it needs to be so properly. (DWR Sutter Yard- A Freitag) 11/01/2016 Erosion/cavity collapse visible on LS toe. Slide gate inside concrete riser located on the WS is in the open position. Need to contact owner to confirm status of crossing and to determine cause of erosion on LS (pipe or concrete box might be leaking). (O. Magana - DWR UCIP) 10/24/2016 Appears abandoned. (DWR Sutter Yard- A Freitag) 4/25/2016 Slide gate in WS box visually appears to be closed as its stem is all the way down. Still cannot look into box to confirm 100% though. (A. Freitag - DWR Sutter Yard) 4/21/2015 Same as last inspection. (A. Freitag - DWR Sutter Yard) 6/23/2014 Same as last inspection. (A. Freitag - DWR Sutter Yard) 12/17/2013 Same as last inspection. (A. Freitag - DWR Sutter Yard) 7/22/2013 Same as last inspection. (A. Freitag - DWR Sutter Yard) 10/30/2012 Unable to close positive closure device due to missing ladder-sluce gate inaccessible. Need to determine the condition of the gate. This crossing was listed in the USACE Periodic Inspections as ID# USACE_CESPK_MA1C_2010_p_0453 for an inaccessible gate box with its ladder broken on the waterward side. (O. Magana - DWR UCIP) FIELD_STRUCT_DESC: 36-inch corrugated metal irrigation pipe through the levee, 21.5 feet below the crown. Slide gate in concrete box on the waterside (WS) end. Pump on the bank. Tall concrete box located on the landside (LS). (Automatic Board Order (ABO) issued as Permit No. 9461, 1974 - Annie D. Propfe) [Additional Reference(s): DWR Levee Log, 1992. USACE Sacramento O&M Manual 137, August 1955, (Station 710+82)].

View of WS at crossing.

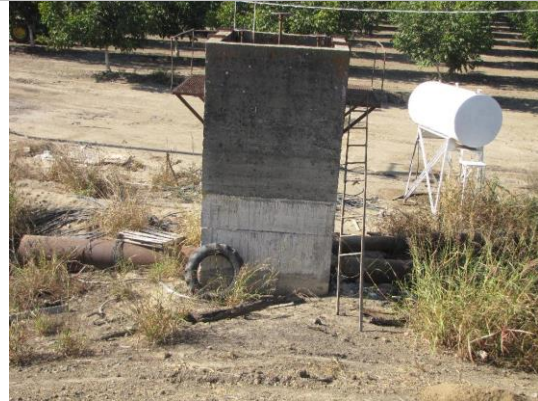
Photo 3 of 3 : UCIP_SP_2017_51908_70375.jpg

FS_ID:51908
 DS_ID:16443
 EP_NO: 9461
 Repair Type: Urgent
 Crossing Status: Found
 UCIP Comments: 5/3/2017 Water was leaking from the LS distribution box during the Jan/Feb 2017 high water event. If this crossing is abandoned then it needs to be so properly. (DWR Sutter Yard- A Freitag)11/01/2016 Erosion/cavity collapse visible on LS toe. Slide gate inside concrete riser located on the WS is in the open position. Need to contact owner to confirm status of crossing and to determine cause of erosion on LS (pipe or concrete box might be leaking). (O. Magana - DWR UCIP)10/24/2016 Appears abandoned.(DWR Sutter Yard- A Freitag)4/25/2016 Slide gate in WS box visually appears to be closed as its stem is all the way down. Still cannot look into box to confirm 100% though. (A. Freitag - DWR Sutter Yard)4/21/2015 Same as last inspection. (A. Freitag - DWR Sutter Yard)6/23/2014 Same as last inspection. (A. Freitag - DWR Sutter Yard)12/17/2013 Same as last inspection. (A. Freitag - DWR Sutter Yard)7/22/2013 Same as last inspection. (A. Freitag - DWR Sutter Yard)10/30/2012 Unable to close positive closure device due to missing ladder-sluce gate inaccessible. Need to determine the condition of the gate. This crossing was listed in the USACE Periodic Inspections as ID# USACE_CESPK_MA1C_2010_p_0453 for an inaccessible gate box with its ladder broken on the waterward side. (O. Magana - DWR UCIP) FIELD_STRUCT_DESC: 36-inch corrugated metal irrigation pipe through the levee, 21.5 feet below the crown. Slide gate in concrete box on the waterside (WS) end. Pump on the bank. Tall concrete box located on the landside (LS). (Automatic Board Order (ABO) issued as Permit No. 9461, 1974 - Annie D. Propfe) [Additional Reference(s): DWR Levee Log, 1992. USACE Sacramento O&M Manual 137, August 1955, (Station 710+82)].

Concrete distribution box located on LS toe.

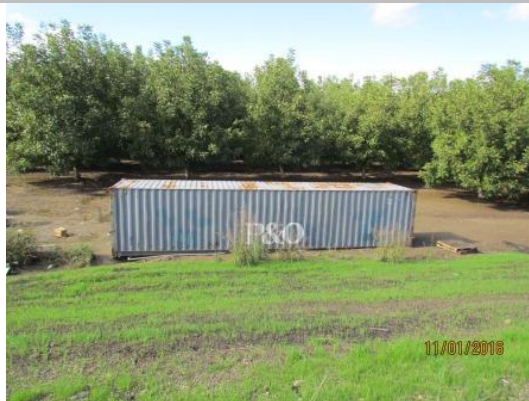
Photo 1 of 1 : SP_2017_MA0001_297_126_20170315_00055.jpg

LM Start	13.48	Rating **	M	Issue No.	126
LM End	13.48	Issue Type +	En	Location *	LS
Category	Earthen Levee			GPS Latitude/Longitude	
				Start	End
Item	Encroachments			39.367832 °	39.367832 °
				-122.015130 °	-122.015130 °
DWR ID	DWR_MA0001_01_f_2016_126				
Comment Code					
EQ : Equipment					
Inspector Comment					
Shipping container stored on landside toe.

View of a shipping container along the landside toe.

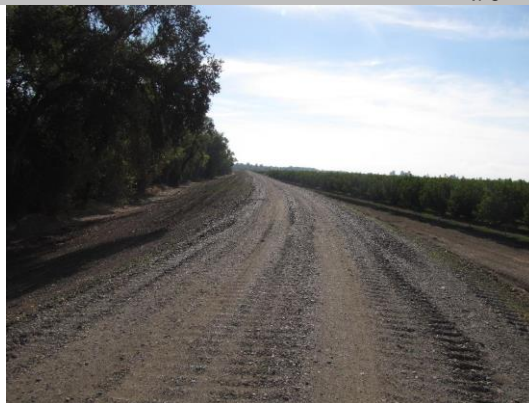
Photo 1 of 2 : UCIP_SP_2017_51910_70379.jpg

FS_ID:51910
DS_ID:16442
EP_NO: N/A
Repair Type: Non-Urgent
Crossing Status: Found
UCIP Comments: 5/3/2017 Abandoned- needs to be done so properly.
(DWR Sutter Yard- A Freitag)10/24/2016 Abandoned.(DWR Sutter Yard- A Freitag)4/25/2016 Abandoned crossing4/21/2015 Slide gate is still buried.6/23/2014 Same as last inspection.12/17/2013 Same as last inspection.7/22/2013 Same as last inspection.10/30/2012 Slide gate is buried-non-functional. This crossing was listed in the USACE Periodic Inspections as ID# USACE_CESPK_MA1C_2010_p_0457 for buried slide gate.
FIELD_STRUCT_DESC: *ABANDONED* 36-inch corrugated metal drainage pipe through the levee at approximately 15-18 feet below the crown. Slide gate on the waterside (WS) end. (Davis Ranches)
[Additional Reference(s): DWR Levee Log, 1992].
FS Date: 5/23/2017 12:02:52 PM

Overview of levee crown looking downstream at crossing.

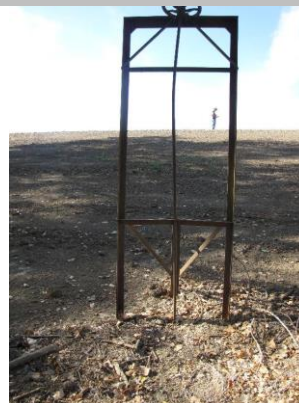
Photo 2 of 2 : UCIP_SP_2017_51910_70380.jpg

WS-Slide gate buried-non-functional.

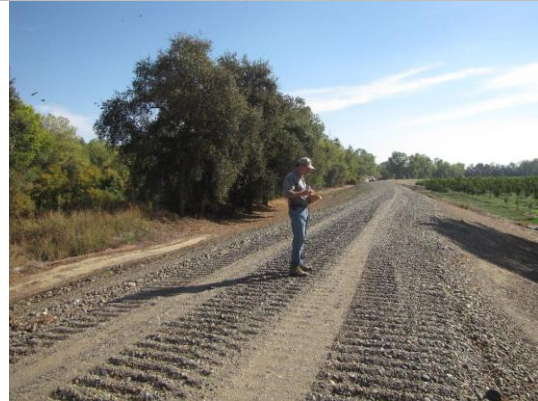
Photo 1 of 3 : UCIP_SP_2017_51912_70383.jpg

FS_ID:51912
DS_ID:16441
EP_NO: 9460
Repair Type: Urgent
Crossing Status: Found
UCIP Comments: 5/3/2017 Water leaked through this crossing during the Jan/Feb 2017 high water event. A concrete pipe of unknown diameter exits the LS distribution box and follows the levee alignment downstream about 120ft and uncontrolled water flowed from that pipe end. If crossing is abandoned then it needs to be done so properly. (DWR Sutter Yard- A Freitag)10/24/2016 This entire crossing now appears to be abandoned. The pvc pipe that was previously connected to the LS well pump is no longer connected and used to fill the box. (DWR Sutter Yard- A Freitag)4/25/2016 WS concrete box appears to be abandoned. LS box appears to get filled by a well pump on LS.4/21/2015 Same as last inspection.6/23/2014 Same as last inspection.12/17/2013 Same as last inspection.7/22/2013 Same as last inspection.10/30/2012 Need to determine if crossing is still being used there are some abandoned features that remain at this crossing-- crossing has been modified. This crossing was listed in the USACE Periodic Inspections as ID# USACE_CESPK_MA1C_2010_p_0464 for abandoned pump station.

View of levee crown looking downstream at crossing.

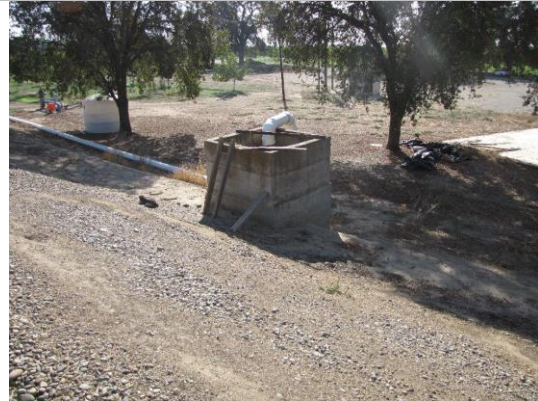
Photo 2 of 3 : UCIP_SP_2017_51912_70382.jpg

FS_ID:51912
DS_ID:16441
EP_NO: 9460
Repair Type: Urgent
Crossing Status: Found
UCIP Comments: 5/3/2017 Water leaked through this crossing during the Jan/Feb 2017 high water event. A concrete pipe of unknown diameter exits the LS distribution box and follows the levee alignment downstream about 120ft and uncontrolled water flowed from that pipe end. If crossing is abandoned then it needs to be done so properly. (DWR Sutter Yard- A Freitag)10/24/2016 This entire crossing now appears to be abandoned. The pvc pipe that was previously connected to the LS well pump is no longer connected and used to fill the box. (DWR Sutter Yard- A Freitag)4/25/2016 WS concrete box appears to be abandoned. LS box appears to get filled by a well pump on LS.4/21/2015 Same as last inspection.6/23/2014 Same as last inspection.12/17/2013 Same as last inspection.7/22/2013 Same as last inspection.10/30/2012 Need to determine if crossing is still being used there are some abandoned features that remain at this crossing-- crossing has been modified. This crossing was listed in the USACE Periodic Inspections as ID# USACE_CESPK_MA1C_2010_p_0464 for abandoned pump station.

Concrete distribution box located on LS toe.

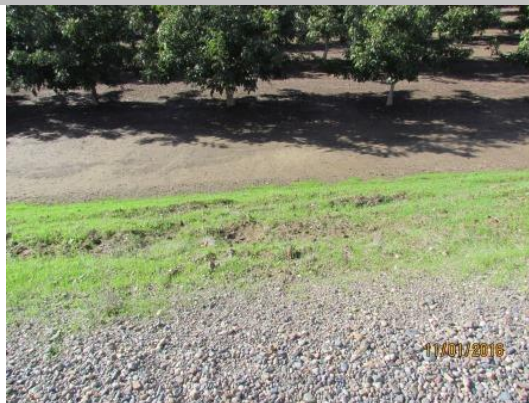
Photo 1 of 1 : SP_2017_MA0001_297_129_20170315_00058.jpg

View of the slope instability caused by vehicles along the landside slope.

LM Start	14.80	Rating **	M	Issue No.	129
LM End	14.80	Issue Type +	Ma	Location *	LS
Category	Earthen Levee			GPS Latitude/Longitude	
				Start	End
Item	Slope Stability			39.386008 °	39.386008 °
				-122.014270 °	-122.014270 °
DWR ID	DWR_MA0001_01_f_2016_129				
Comment Code					
S3 : Repair the levee slope damaged by vehicle traffic and prevent access where possible.					
Inspector Comment

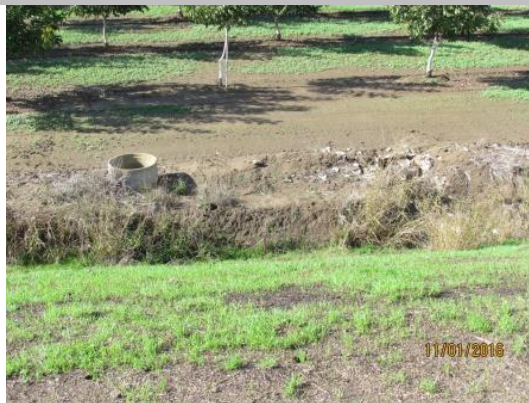
Photo 1 of 1 : SP_2017_MA0001_297_130_20170315_00059.jpg

LM Start	15.38	Rating **	M	Issue No.	130
LM End	15.38	Issue Type +	En	Location *	LS
Category	Earthen Levee			GPS Latitude/Longitude	
				Start	End
Item	Encroachments			39.393985 °	39.393985 °
				-122.011217 °	-122.011217 °
DWR ID	DWR_MA0001_01_f_2016_130				
Comment Code					
DT : Ditch					
Inspector Comment					
Small ditch on the landside toe.

View of a ditch along the landside toe.

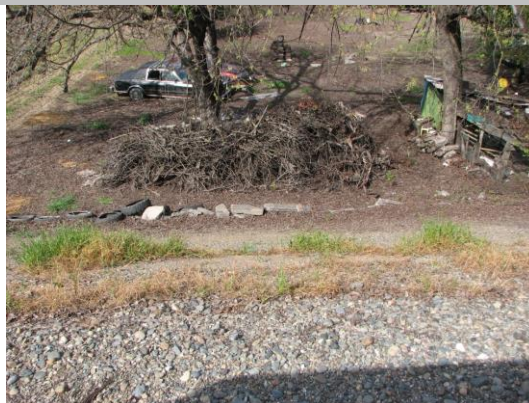
Photo 1 of 1 : SP_2017_MA0001_297_85_20170315_00019.jpg

LM Start	15.79	Rating **	U	Issue No.	85
LM End	15.79	Issue Type +	En	Location *	LS
Category	Earthen Levee			GPS Latitude/Longitude	
				Start	End
Item	Encroachments			39.399929 °	39.399929 °
				-122.010028 °	-122.010028 °
DWR ID	DWR_MA0001_01_s_2016_85				
Comment Code					
DE : Debris					
Inspector Comment					
prunings, concrete and tires.

View of prunings, concrete, and tires along the toe.

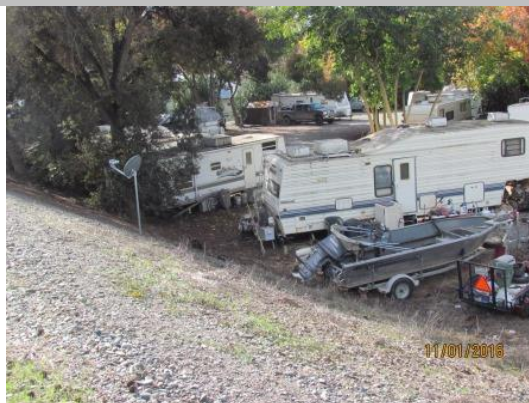
Photo 1 of 1 : SP_2017_MA0001_297_86_20170315_00020.jpg

LM Start	15.84	Rating **	U	Issue No.	86
LM End	15.90	Issue Type +	En	Location *	LS
Category	Earthen Levee			GPS Latitude/Longitude	
				Start	End
Item	Encroachments			39.400601 °	39.401365 °
				-122.009889 °	-122.009374 °
DWR ID	DWR_MA0001_01_s_2016_86				
Comment Code					
BU : Building					
Inspector Comment					
Mobile homes and trailers.

View of the mobile homes and trailers along the landside toe.

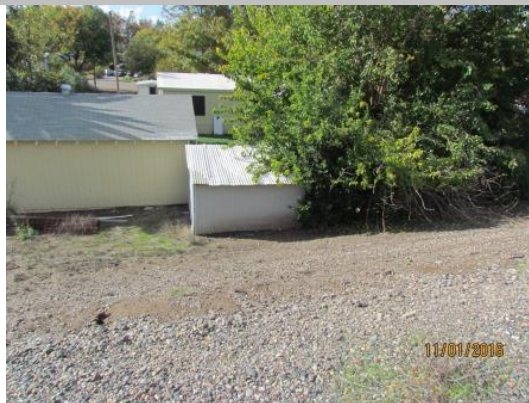
Photo 1 of 1 : SP_2017_MA0001_297_87_20170315_00021.jpg

LM Start	15.95	Rating **	U	Issue No.	87
LM End	15.95	Issue Type +	En	Location *	LS
Category	Earthen Levee			GPS Latitude/Longitude	
				Start	End
Item	Encroachments			39.401994 °	39.401994 °
				-122.009352 °	-122.009352 °
DWR ID	DWR_MA0001_01_s_2016_87				
Comment Code					
BU : Building					
Inspector Comment

View of a shed along the landside toe.

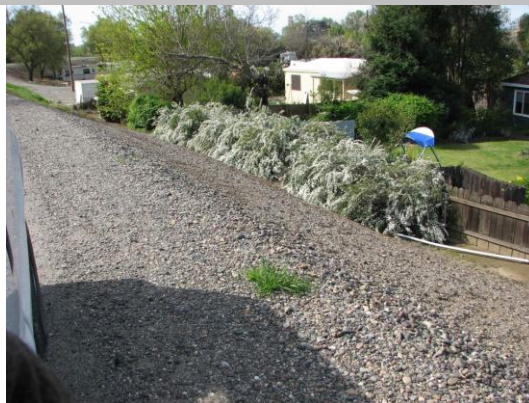
Photo 1 of 1 : SP_2017_MA0001_297_88_20170315_00022.jpg

LM Start	15.95	Rating **	U	Issue No.	88
LM End	15.97	Issue Type +	En	Location *	LS
Category	Earthen Levee			GPS Latitude/Longitude	
				Start	End
Item	Vegetation			39.402130 °	39.402400 °
				-122.009354 °	-122.009344 °
DWR ID	DWR_MA0001_01_s_2016_88				
Comment Code					
V6 : Landscaping					
Inspector Comment

View of landscaping obstructing visibility and access.

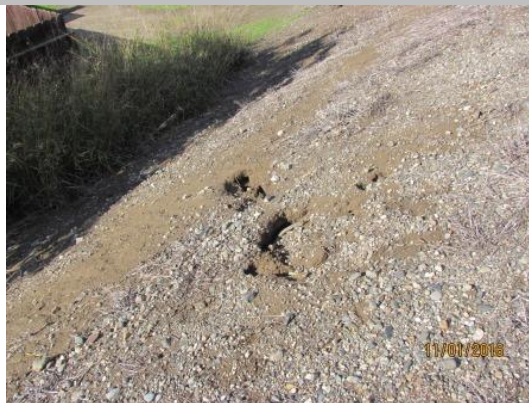
Photo 1 of 1 : SP_2017_MA0001_297_132_20170315_00060.jpg

LM Start	15.99	Rating **	M	Issue No.	132
LM End	15.99	Issue Type +	Ma	Location *	LS
Category	Earthen Levee			GPS Latitude/Longitude	
				Start	End
Item	Animal Control			39.402605 °	39.402605 °
				-122.009348 °	-122.009348 °
DWR ID	DWR_MA0001_01_f_2016_132				
Comment Code					
A3 : No rodents visible, but rodent burrows visible; need to backfill and compact or grout burrows.					
Inspector Comment

View of the rodent holes along the landside slope.

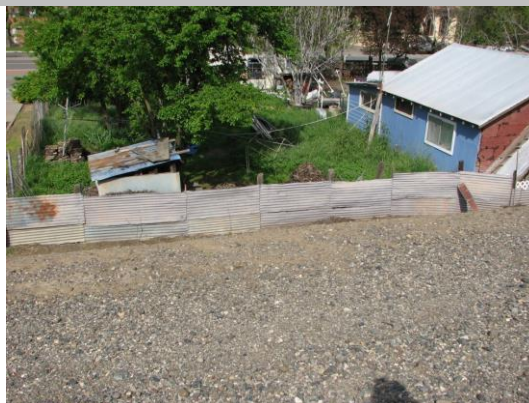
Photo 1 of 1 : SP_2017_MA0001_297_89_20170315_00023.jpg

LM Start	16.00	Rating **	U	Issue No.	89
LM End	16.02	Issue Type +	En	Location *	LS
Category	Earthen Levee			GPS Latitude/Longitude	
				Start	End
Item	Encroachments			39.402756 °	39.403040 °
				-122.009261 °	-122.009186 °
DWR ID	DWR_MA0001_01_s_2016_89				
Comment Code					
BU : Building					
Inspector Comment					
Red house and metal fence.

Corrugated metal fence obstructing visibility and access

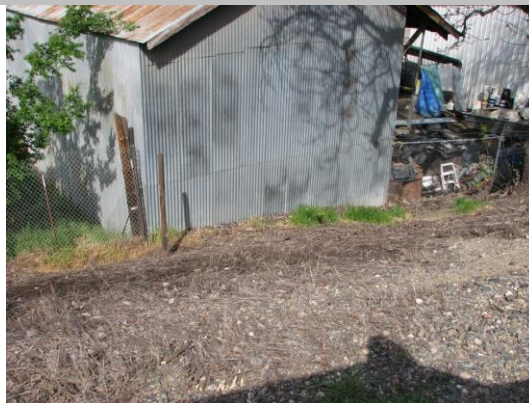
Photo 1 of 1 : SP_2017_MA0001_297_90_20170315_00024.jpg

LM Start	16.03	Rating **	U	Issue No.	90
LM End	16.03	Issue Type +	En	Location *	LS
Category	Earthen Levee			GPS Latitude/Longitude	
				Start	End
Item	Encroachments			39.403206 °	39.403206 °
				-122.009116 °	-122.009116 °
DWR ID	DWR_MA0001_01_s_2016_90				
Comment Code					
BU : Building					
Inspector Comment					
metal sided building

View of a corrugated metal building obstructing visibility and access.

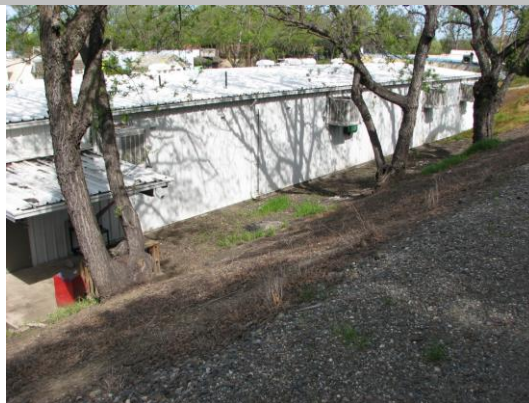
Photo 1 of 1 : SP_2017_MA0001_297_91_20170315_00025.jpg

LM Start	16.06	Rating **	U	Issue No.	91
LM End	16.06	Issue Type +	En	Location *	LS
Category	Earthen Levee			GPS Latitude/Longitude	
				Start	End
Item	Encroachments			39.403565 °	39.403565 °
				-122.009039 °	-122.009039 °
DWR ID	DWR_MA0001_01_s_2016_91				
Comment Code					
BU : Building					
Inspector Comment					
long, white metal building with several AC units

View of a building obstructing access.

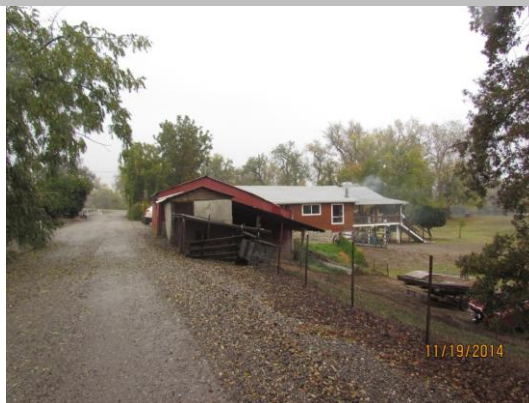
Photo 1 of 1 : SP_2017_MA0001_297_14_20170315_00009.jpg

LM Start	16.08	Rating **	U	Issue No.	14
LM End	16.08	Issue Type +	En	Location *	WS
Category	Earthen Levee			GPS Latitude/Longitude	
				Start	End
Item	Encroachments			39.403930 °	39.403930 °
				-122.008925 °	-122.008925 °
DWR ID	DWR_MA0001_01_s_2012_14				
Comment Code					
BU : Building					
Inspector Comment

View of the building on the waterside slope.

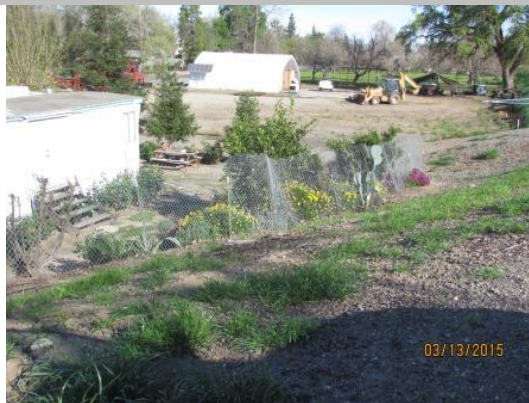
Photo 1 of 1 : SP_2017_MA0001_297_74_20170315_00017.jpg

LM Start	16.10	Rating **	M	Issue No.	74
LM End	16.10	Issue Type +	En	Location *	LS
Category	Earthen Levee			GPS Latitude/Longitude	
				Start	End
Item	Vegetation			39.404255 °	39.404255 °
				-122.008842 °	-122.008842 °
DWR ID	DWR_MA0001_01_s_2015_74				
Comment Code					
V6 : Landscaping					
Inspector Comment					
Remove the landscape from the landside slope and toe.

View of the landscape along the landside slope and toe.

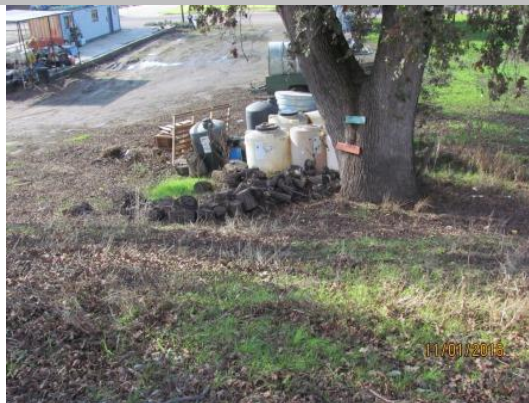
Photo 1 of 1 : SP_2017_MA0001_297_133_20170315_00061.jpg

LM Start	16.17	Rating **	M	Issue No.	133
LM End	16.17	Issue Type +	En	Location *	LS
Category	Earthen Levee			GPS Latitude/Longitude	
				Start	End
Item	Encroachments			39.405147 °	39.405147 °
				-122.008630 °	-122.008630 °
DWR ID	DWR_MA0001_01_f_2016_133				
Comment Code					
FW : Firewood					
Inspector Comment

View of firewood and containers along the landside toe.

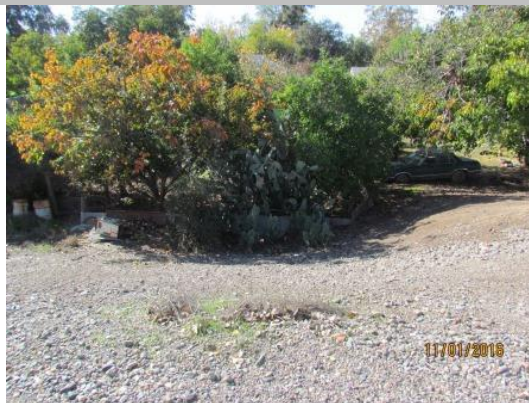
Photo 1 of 1 : SP_2017_MA0001_297_134_20170315_00062.jpg

LM Start	16.26	Rating **	M	Issue No.	134
LM End	16.26	Issue Type +	En	Location *	LS
Category	Earthen Levee			GPS Latitude/Longitude	
				Start	End
Item	Vegetation			39.406520 °	39.406520 °
				-122.008635 °	-122.008635 °
DWR ID	DWR_MA0001_01_f_2016_134				
Comment Code					
V6 : Landscaping					
Inspector Comment

View of cactus and fruit trees along the landside toe blocking visibility.

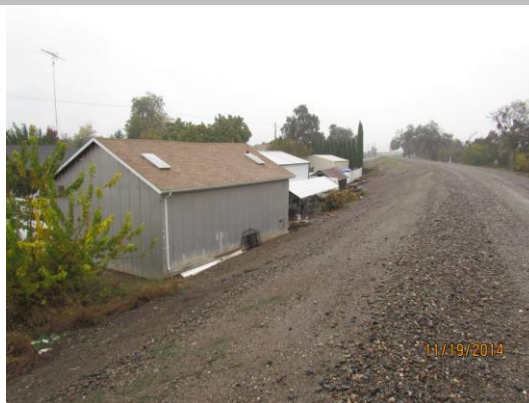
Photo 1 of 1 : SP_2017_MA0001_297_46_20170315_00015.jpg

LM Start	16.31	Rating **	U	Issue No.	46
LM End	16.33	Issue Type +	En	Location *	LS
Category	Earthen Levee			GPS Latitude/Longitude	
				Start	End
Item	Encroachments			39.407225 °	39.407545 °
				-122.008570 °	-122.008640 °
DWR ID	DWR_MA0001_01_s_2012_46				
Comment Code					
BU : Building					
Inspector Comment

View of the building along the landside toe.

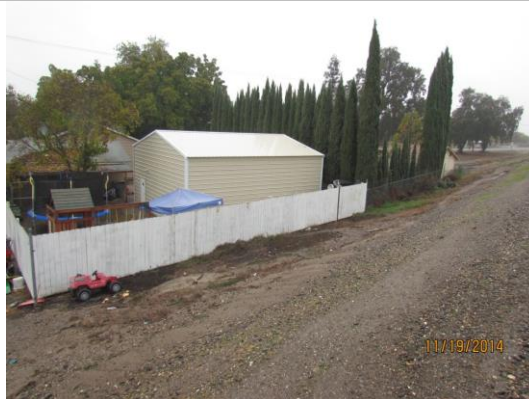
Photo 1 of 1 : SP_2017_MA0001_297_47_20170315_00016.jpg

LM Start	16.34	Rating **	U	Issue No.	47
LM End	16.35	Issue Type +	En	Location *	LS
Category	Earthen Levee			GPS Latitude/Longitude	
				Start	End
Item	Encroachments			39.407670 °	39.407823 °
				-122.008685 °	-122.008740 °
DWR ID	DWR_MA0001_01_s_2012_47				
Comment Code					
FE : Fence					
Inspector Comment

View of the fence along the landside toe.

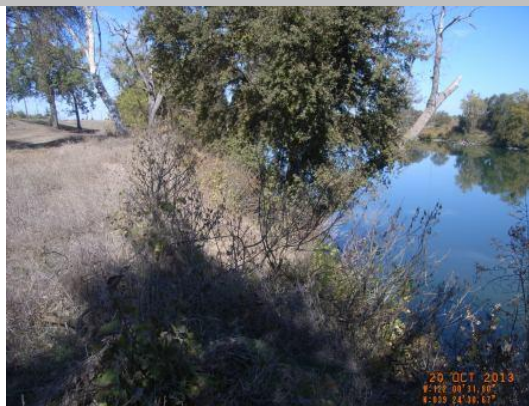
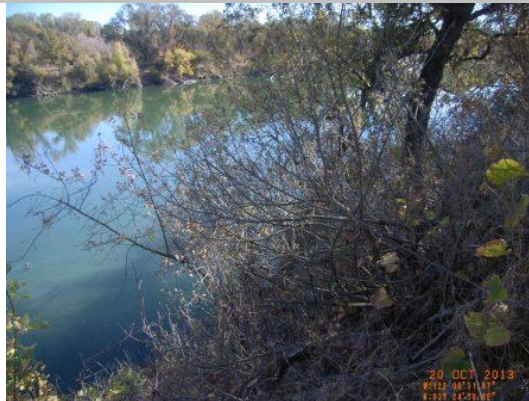
LM Start	16.35	Rating **	M	Issue No.	9
LM End	16.58	Issue Type +	Ma	Location *	WS
Category	Supplemental			GPS Latitude/Longitude	
				Start	End
Item	2015 USACE Erosion Survey, DRAFT			39.407837 °	39.411111 °
				-122.008763 °	-122.009238 °
DWR ID	DWR_MA0001_01_s_2016_9				
Comment Code					
Inspector Comment					
Erosion site added in 1997 and removed in 2005. 2009 - Site added back in, hard toe with slow moving erosion. Potential geotechnical failure. 2011 - Site extended downstream. 2015: Last observed in 2013. [2015 Site ID: SAC_164-3_R]

USACE 2013 Photo #1

USACE 2013 Photo #2

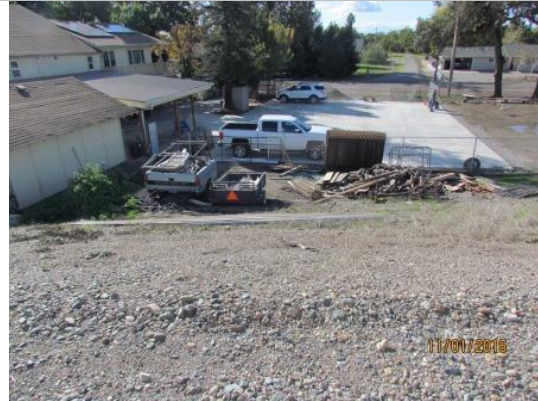
Photo 1 of 1 : SP_2017_MA0001_297_135_20170315_00063.jpg

LM Start	16.37	Rating **	M	Issue No.	135
LM End	16.37	Issue Type +	En	Location *	LS
Category	Earthen Levee			GPS Latitude/Longitude	
				Start	End
Item	Encroachments			39.408073 °	39.408073 °
				-122.009058 °	-122.009058 °
DWR ID	DWR_MA0001_01_f_2016_135				
Comment Code					
EQ : Equipment					
Inspector Comment					
Debris, metal, and firewood on the landside toe.

View of metal sheets along the levee slope and debris and firewood along the landside toe.

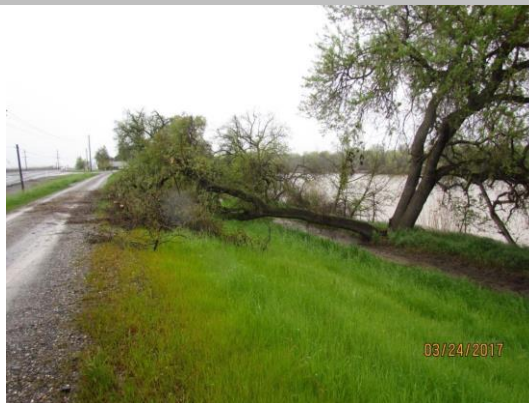
Photo 1 of 1 : SP_2017_MA0001_297_160_20170330_00188.jpg

LM Start	16.52	Rating **	M	Issue No.	160
LM End	16.52	Issue Type +	En	Location *	WS
Category	Earthen Levee			GPS Latitude/Longitude	
				Start	End
Item	Encroachments			39.410205 °	39.410205 °
				-122.009650 °	-122.009650 °
DWR ID	DWR_MA0001_01_s_2017_160				
Comment Code					
TR : Tree or limb					
Inspector Comment					
Remove the tree from the waterside slope and toe.

View of the tree on the waterside slope and toe.

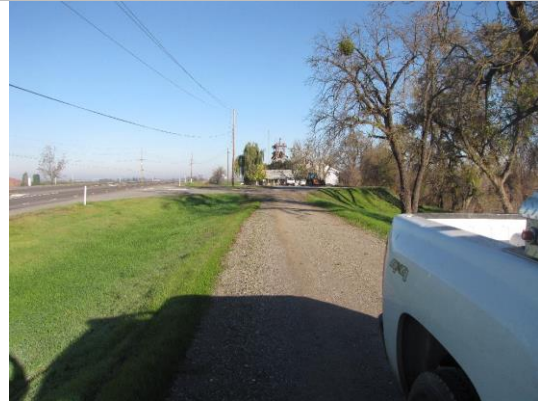
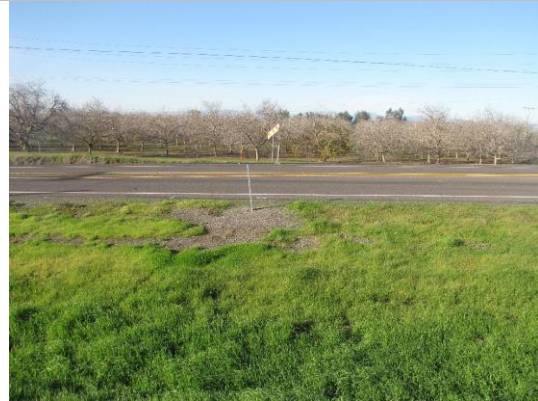
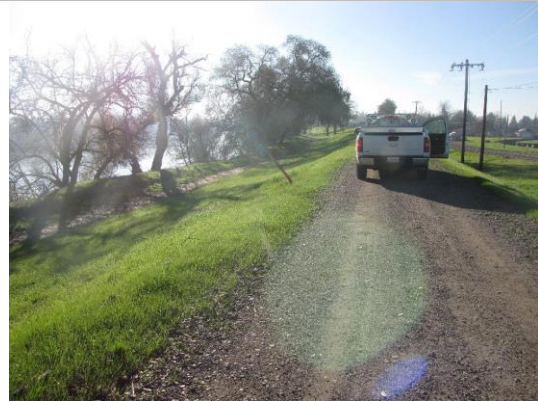
FS_ID:51916
DS_ID:16448
EP_NO: 14424
Repair Type: Non-Urgent
Crossing Status: Found
UCIP Comments: 5/3/2017 WS sign still knocked over- needs to be replaced. (DWR Sutter Yard- AFreitag)10/24/2016 WS marker sign still knocked over.(DWR Sutter Yard- AFreitag)4/25/2016 WS marker sign is still knocked over.4/21/2015 Same as last inspection.11/3/2014 (DWR-Olivia) Need to contact owner to determine when markers will be placed. 6/23/2014 Same as last inspection.12/17/2013 Same as last inspection7/22/2013 Same as last inspection.12/2012 Waiting for information regarding crossing from PG&E. Regarding damage warning sign--PG&E has initiated a project to replace pipeline crossing sign and utility markers, as required by DOT codes/regulations.11/2012 Utility warning sign damaged. Olivia (UCIP team) is coordinating with PG&E to determine more info on crossing.
FIELD_STRUCT_DESC: 12-inch gas pipe through the levee, 30-inches below the crown. This 12-inch replacement pipe was installed by horizontally directionally drilling under the State HWY. Crossing is cathodically protected against external corrosion. Line was bored with a minimum cover of 48 feet under the right bank levee, 60 feet under the right bank, 25 feet under the channel and 52 feet under the left bank. Emergency contact: Monte Penland, Gas Maintenance Supervisor, 15871 Central Street, Meridian, CA 95957; Office No. 530-634-6520 or Mobile No. 530-356-7396. Utility crossing coordinates are approximate. This pipe is under pressure and cathodic protection (CP) readings are taken on a regular schedule. (Permit No. 14424, 1988 - Pacific Gas & Electric [PG&E]) [Additional Reference(s): DWR Levee Log, 1992].

View just upstream of utility crossing.

View of utility marker located on LS across hwy.

View of levee looking downstream at crossing.
